# **Assessment of Dam Safety of Coal Combustion Surface Impoundments**

**Indianapolis Power & Light Company**

**Eagle Valley Generating Station**

**November 15, 2010**

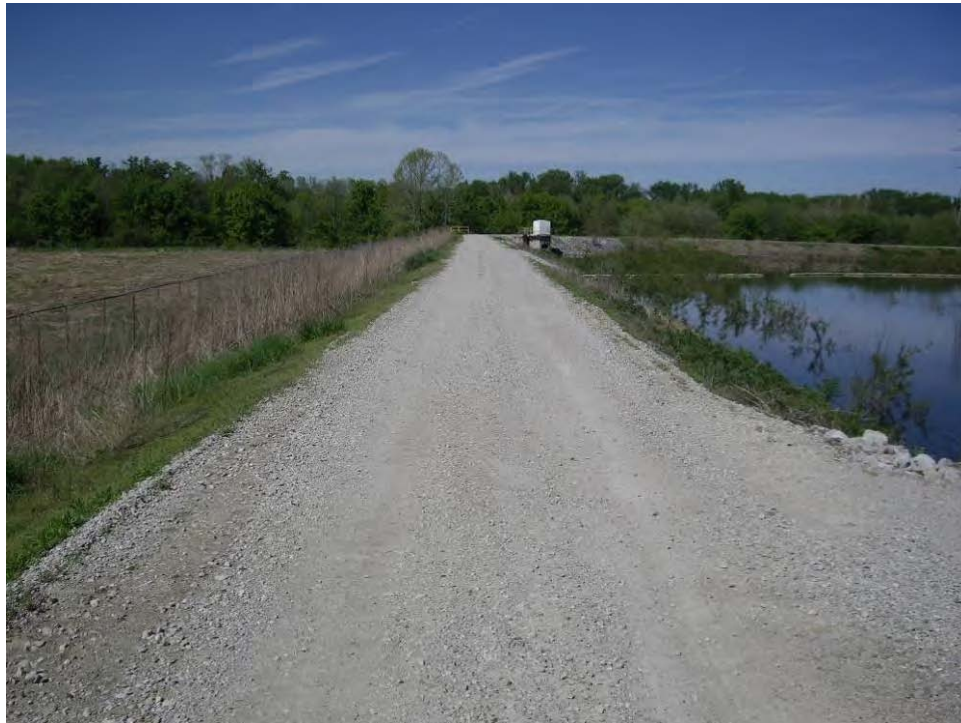
56. Pond C – West embankment crest, looking north

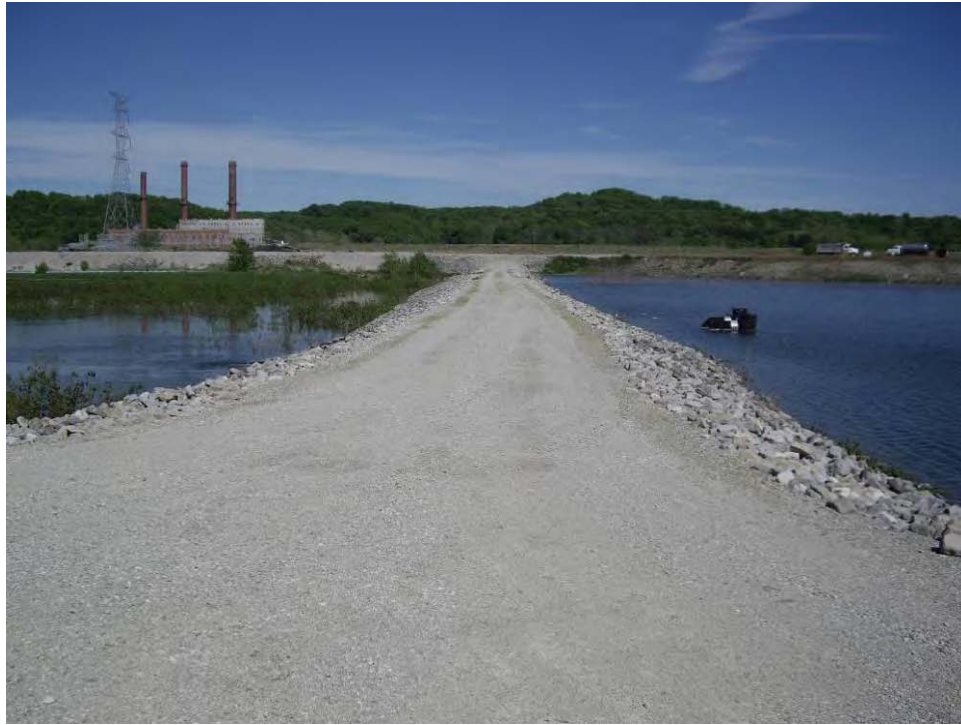
57. Crest of divider embankment B/C, looking east.

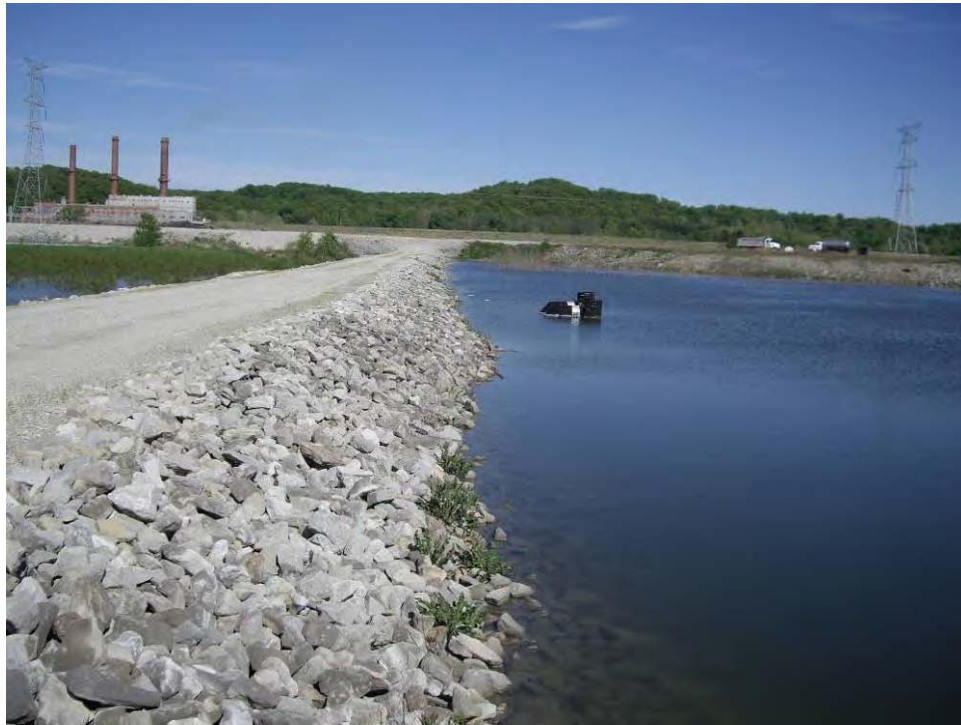
58. South slope of divider embankment B/C, looking east.

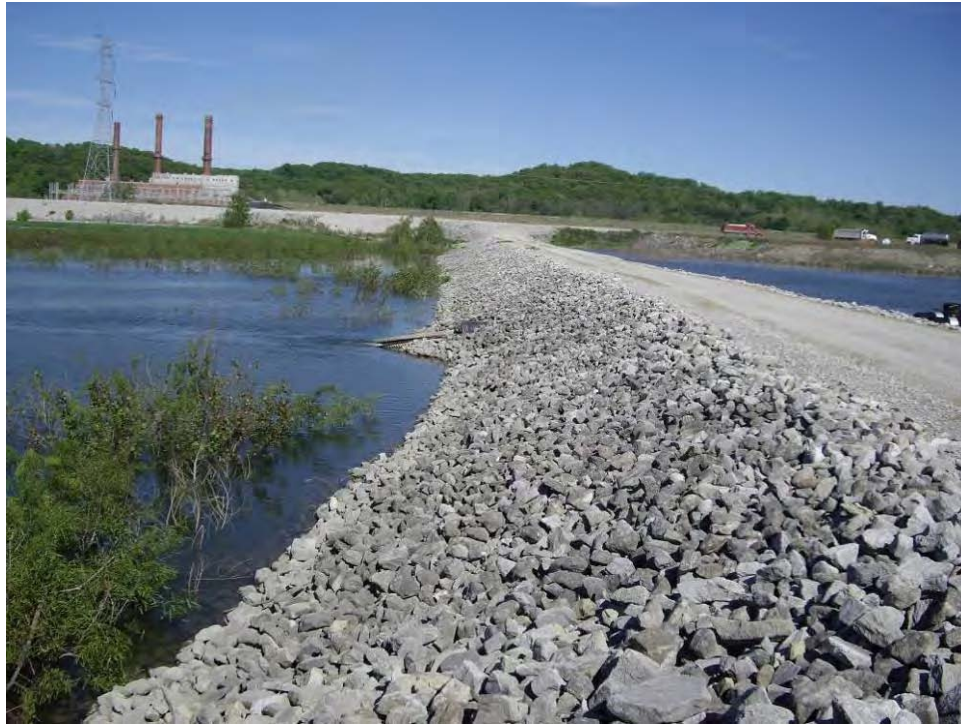
59. North slope of divider embankment B/C looking east.

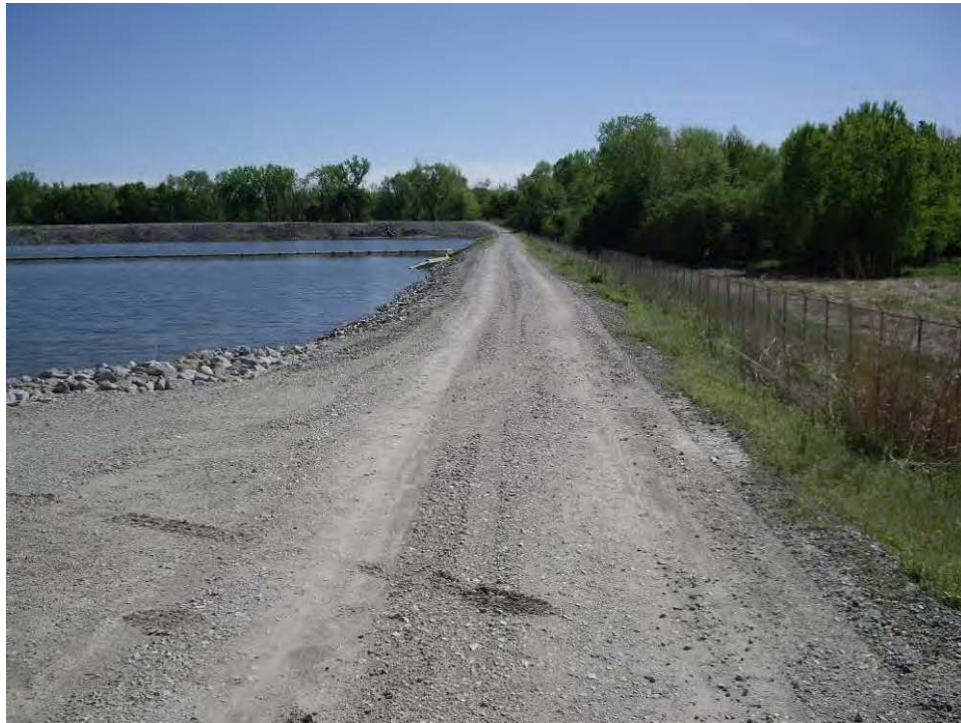
60. Pond B – west embankment crest, looking south.

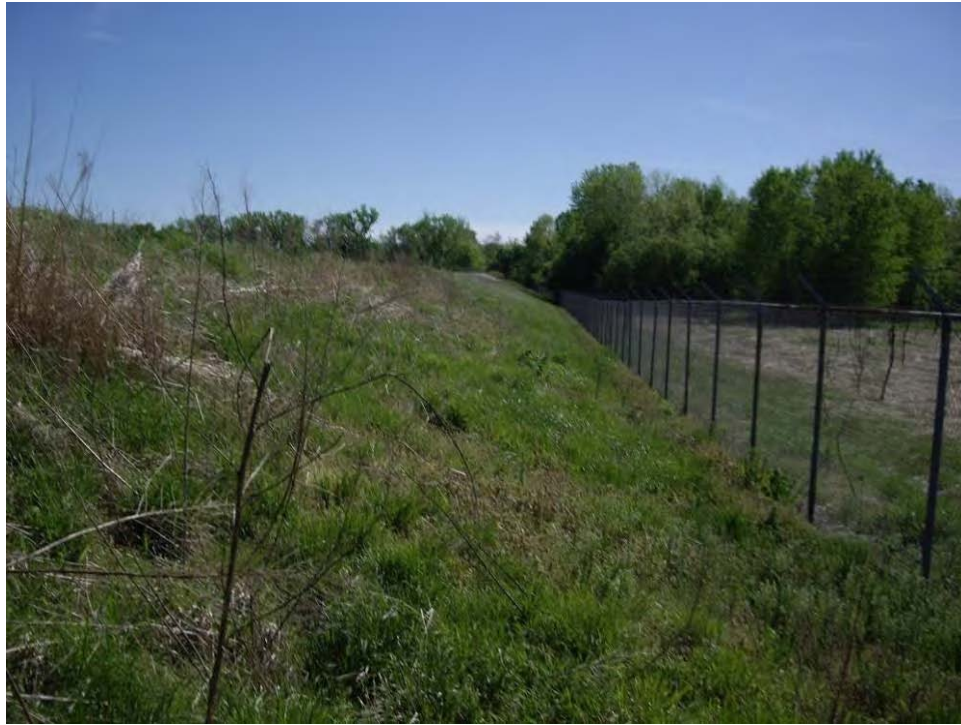
61. Pond B – west embankment exterior slope, looking south.

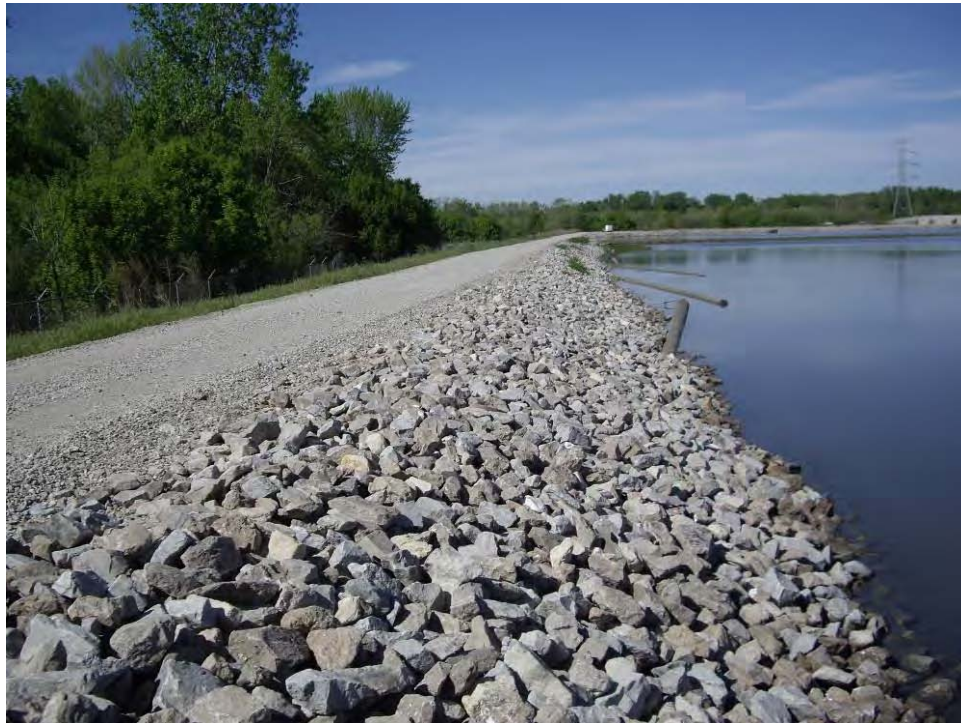
62. Pond B – west embankment interior slope, looking north

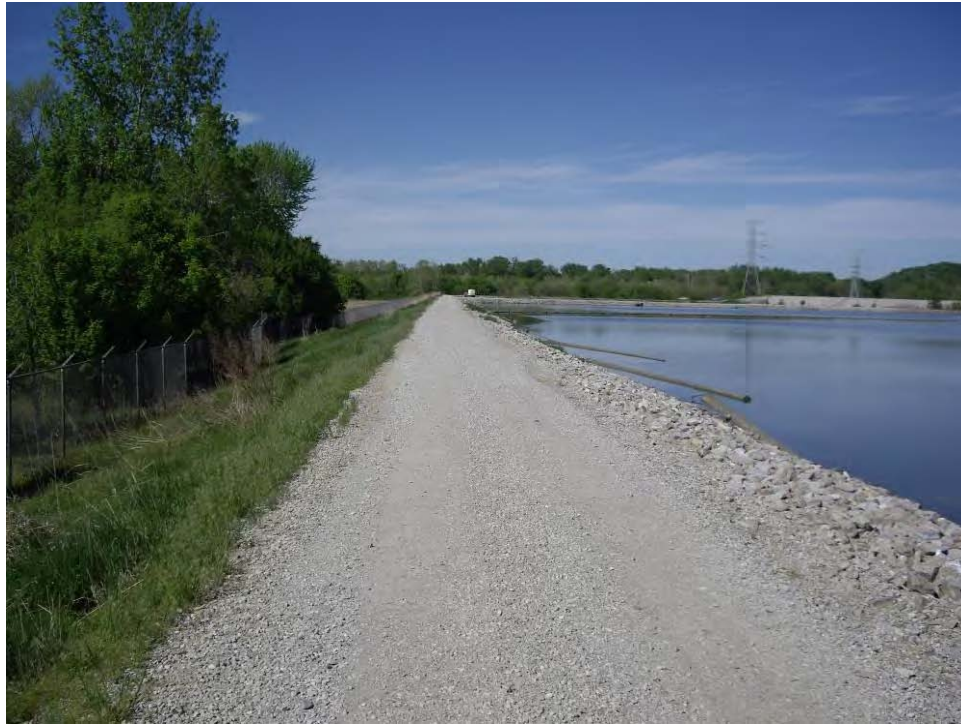
63. Pond B – west embankment crest, looking north

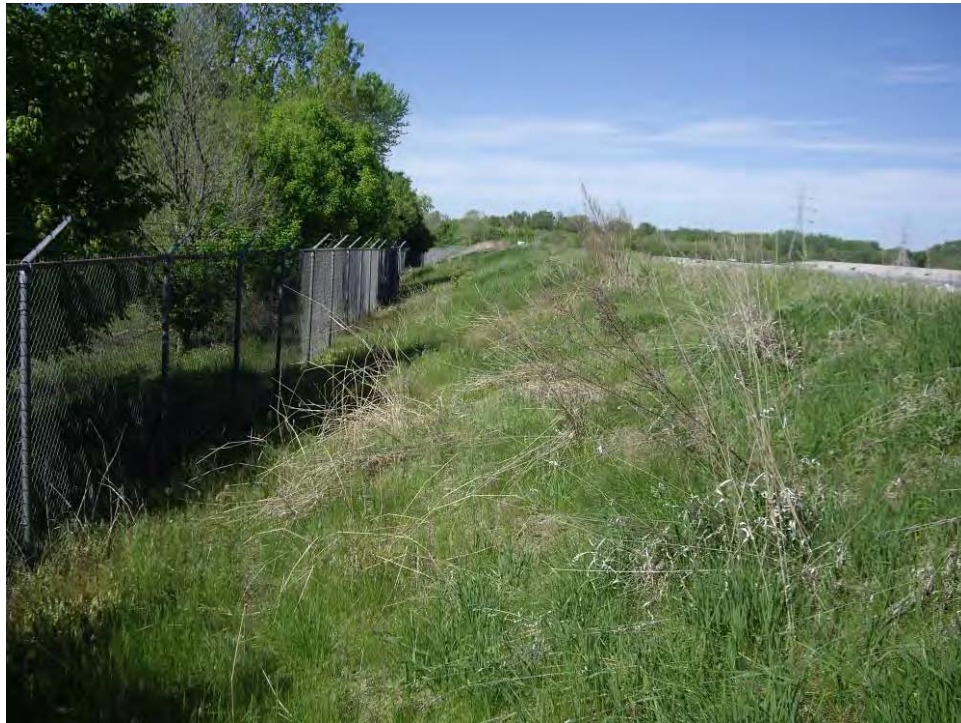
64. Pond B – west embankment exterior slope, looking north

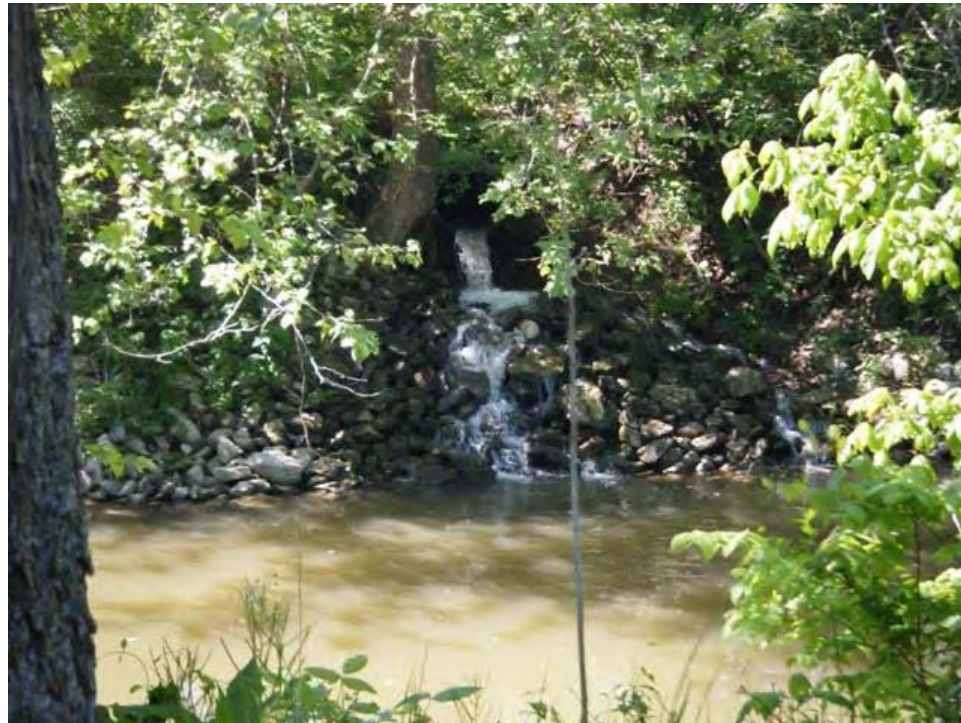
66. Pond C - Outlet structure outfall to discharge canal, looking south.

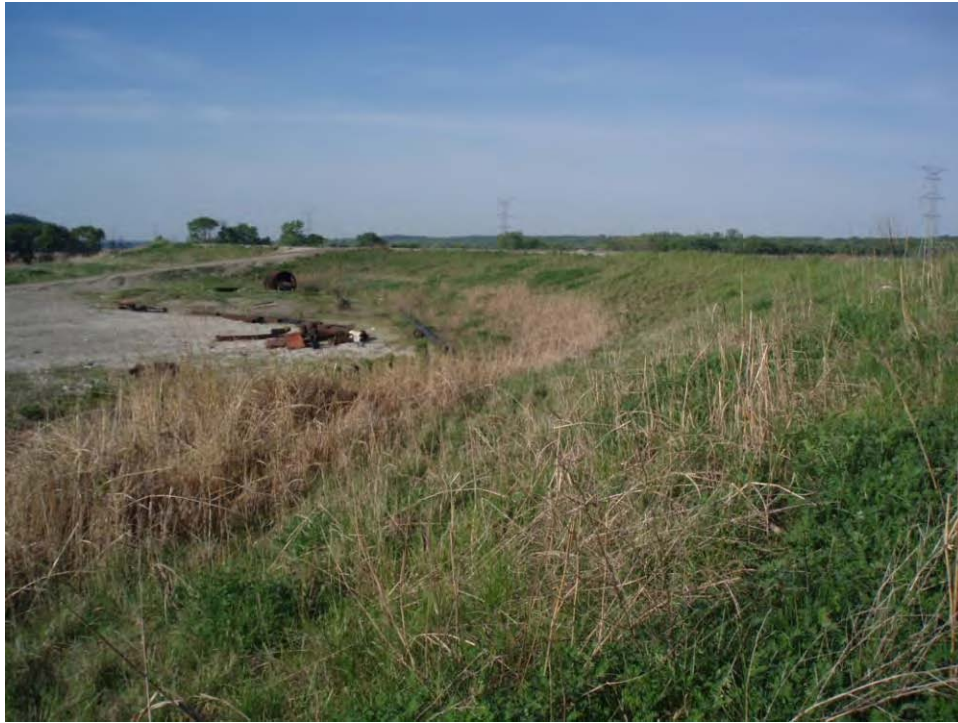
67. Pond D - east embankment exterior slope, looking southwest.

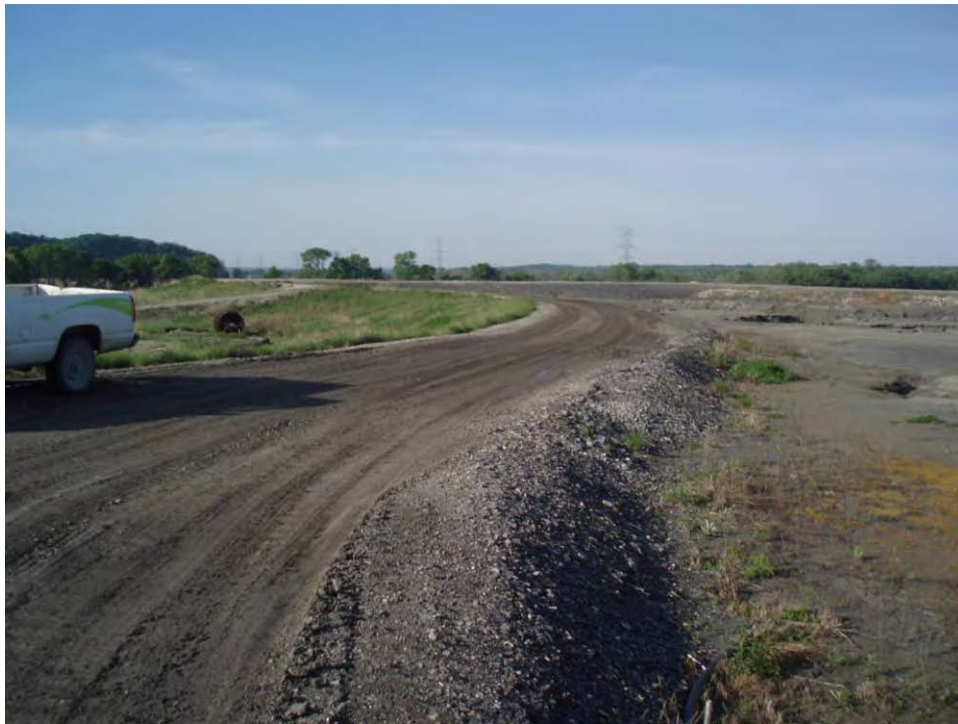
68. Pond D - east embankment crest, looking southwest.

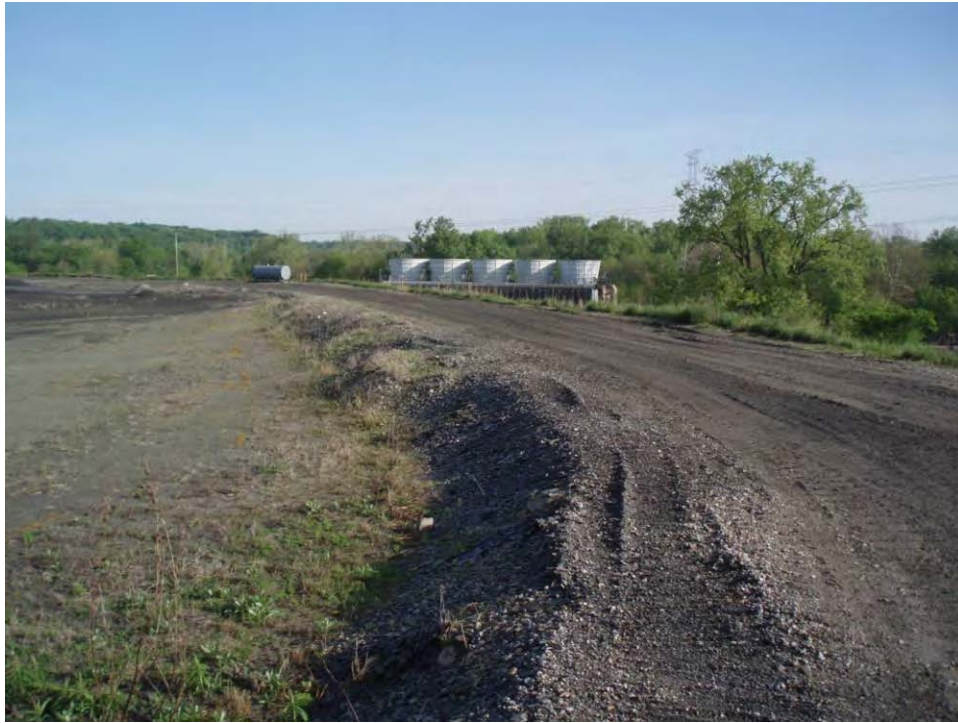
69. Pond D – north embankment crest, looking northwest.

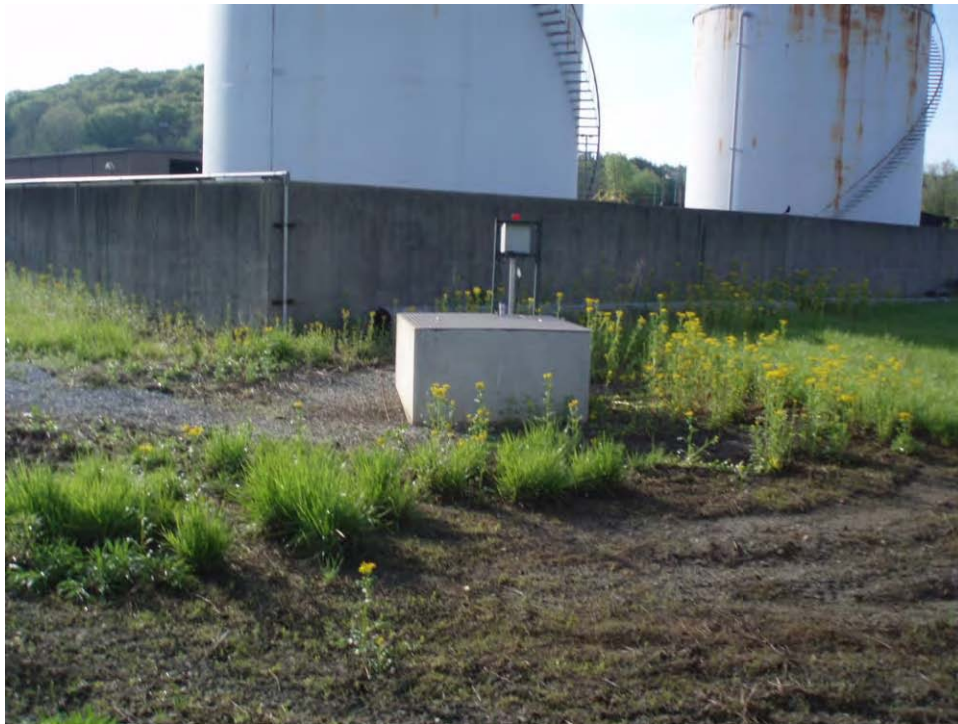
70. Pond D – north embankment toe drain sump pit located in northeast downstream area.

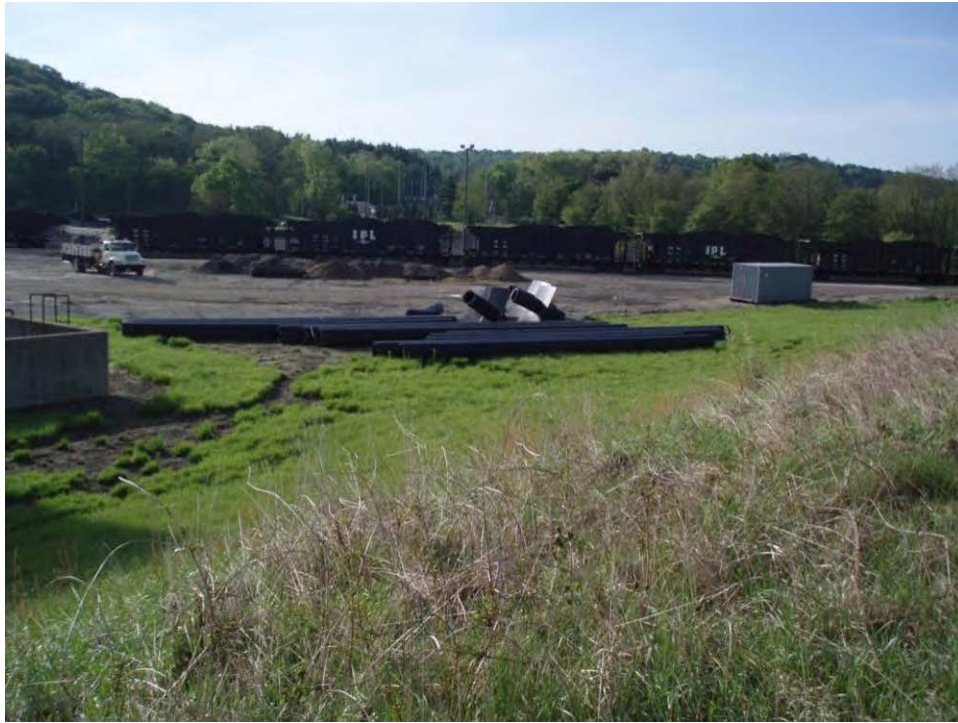
71. Pond D – East embankment downstream area looking southeast. Note new piping for Ponds D & E.

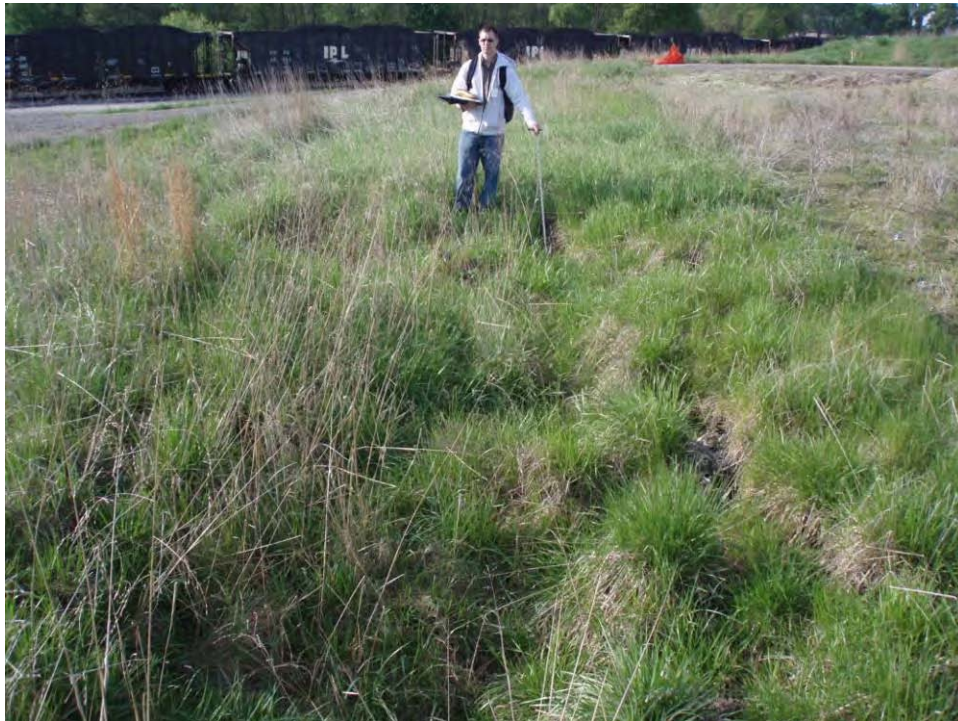
72. Pond D – Erosion rill and depression on east embankment buttress berm, looking south.

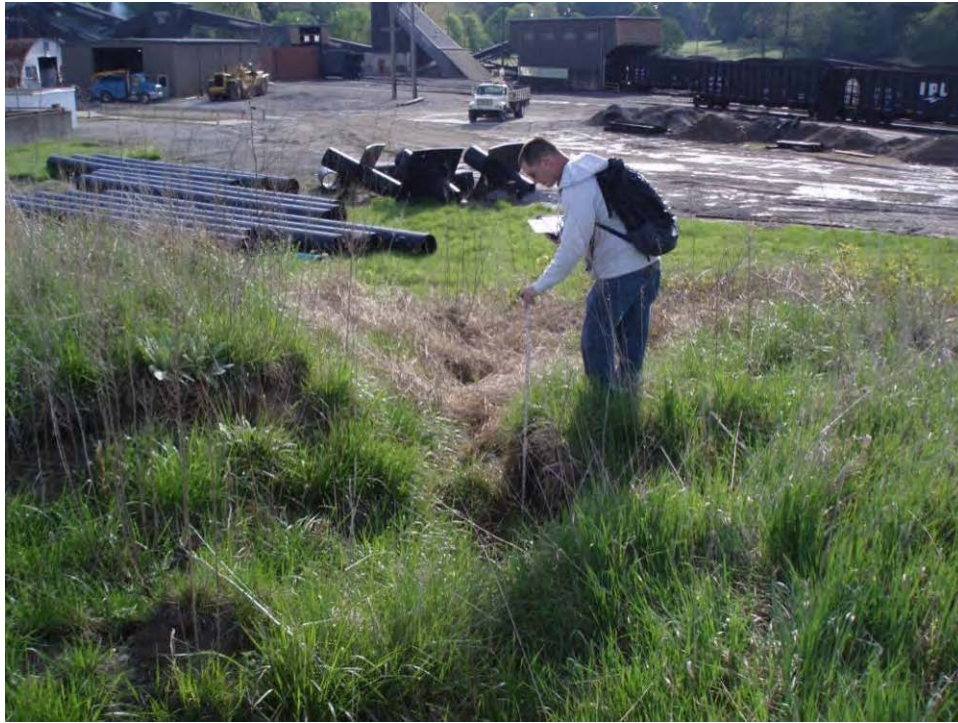
73. Pond D – Erosion rill on east embankment buttress berm, looking northeast

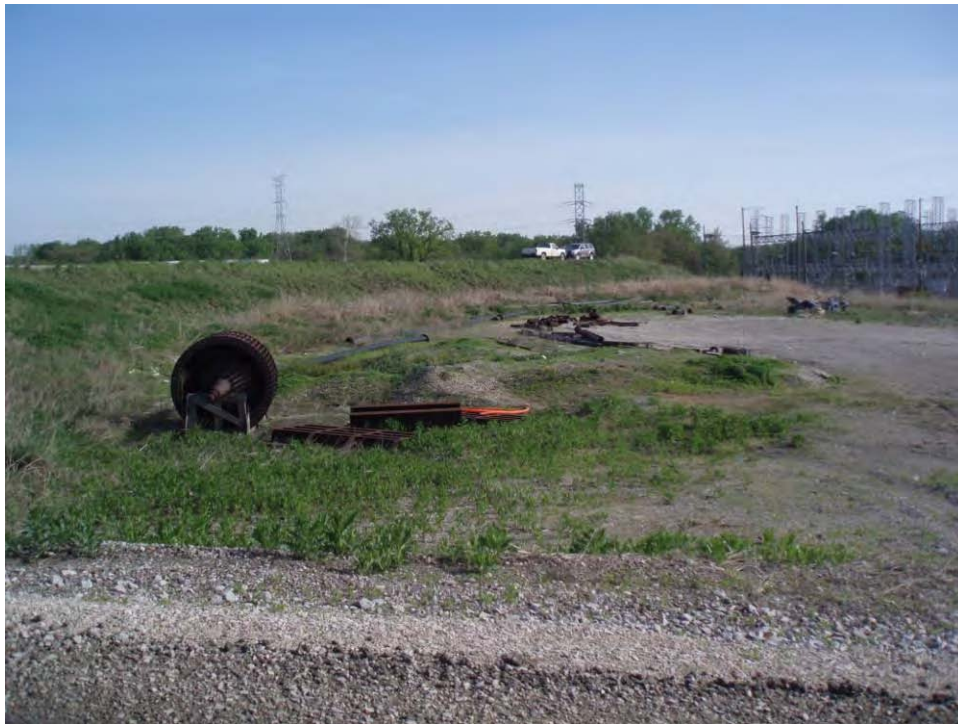
74. Pond D – Crest of east embankment buttress berm, looking north

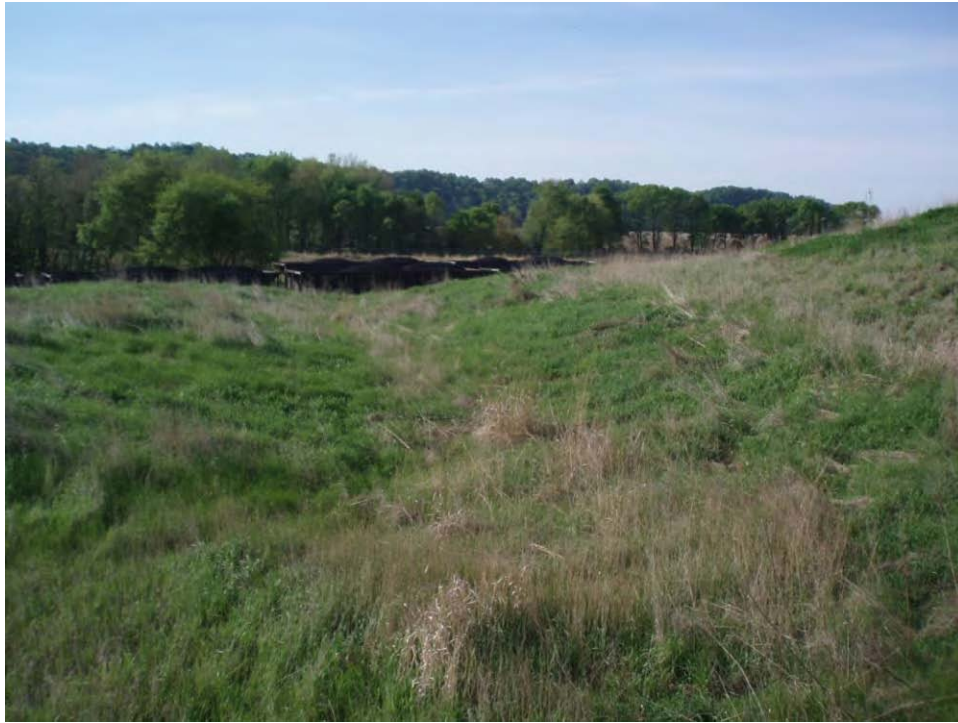
75. Pond D – Crest of east embankment buttress berm, looking south

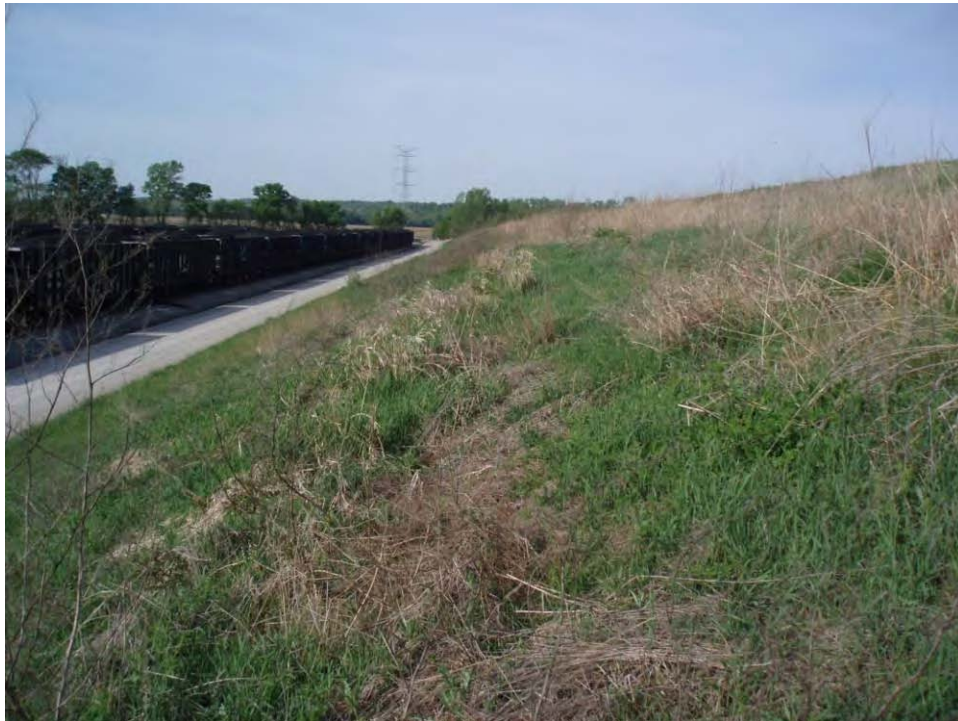
76. Pond D – Southeast embankment exterior slope, looking southwest.

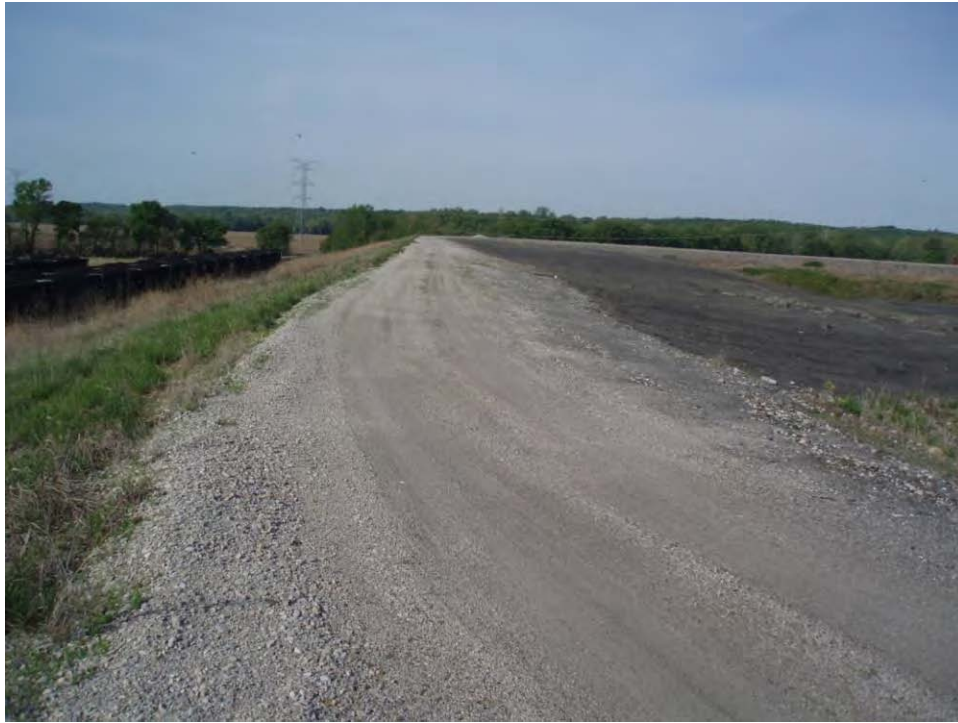
77. Pond D - Southeast embankment crest, looking southwest.

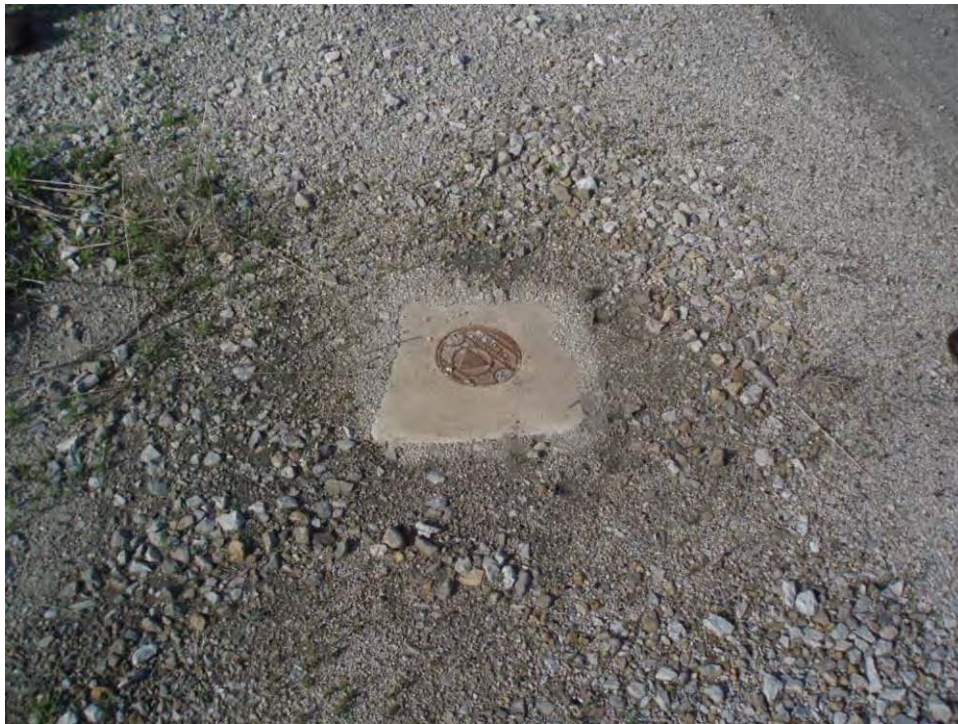
78. Piezometer PZ-2 on Pond D east embankment crest installed by BT<sup>2</sup> on 6/12/08.

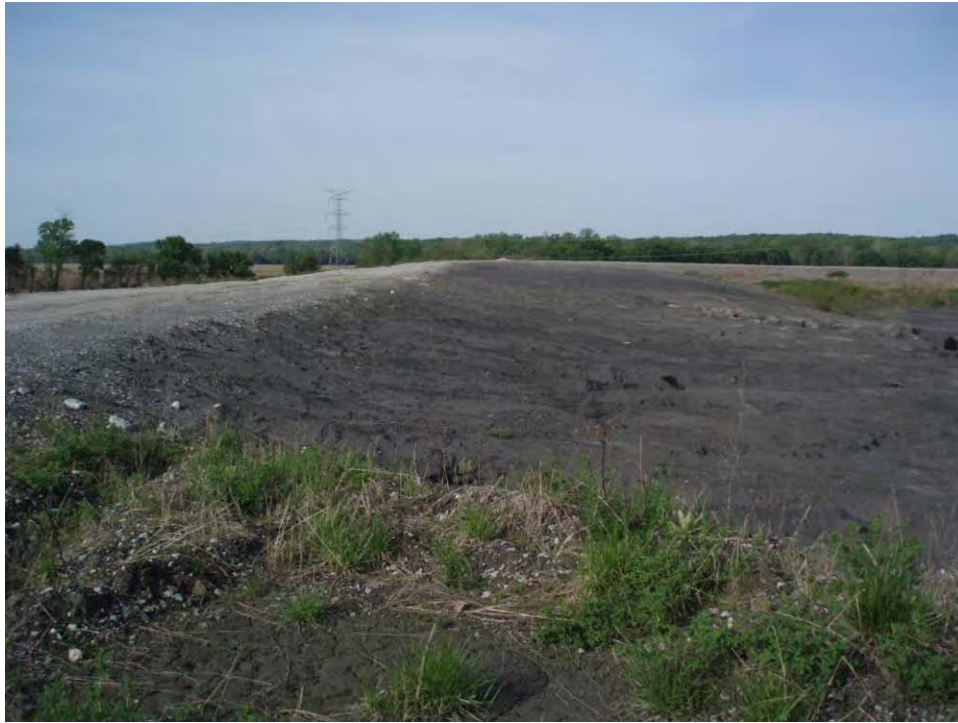
79. Pond D – Southeast embankment interior area, looking southwest

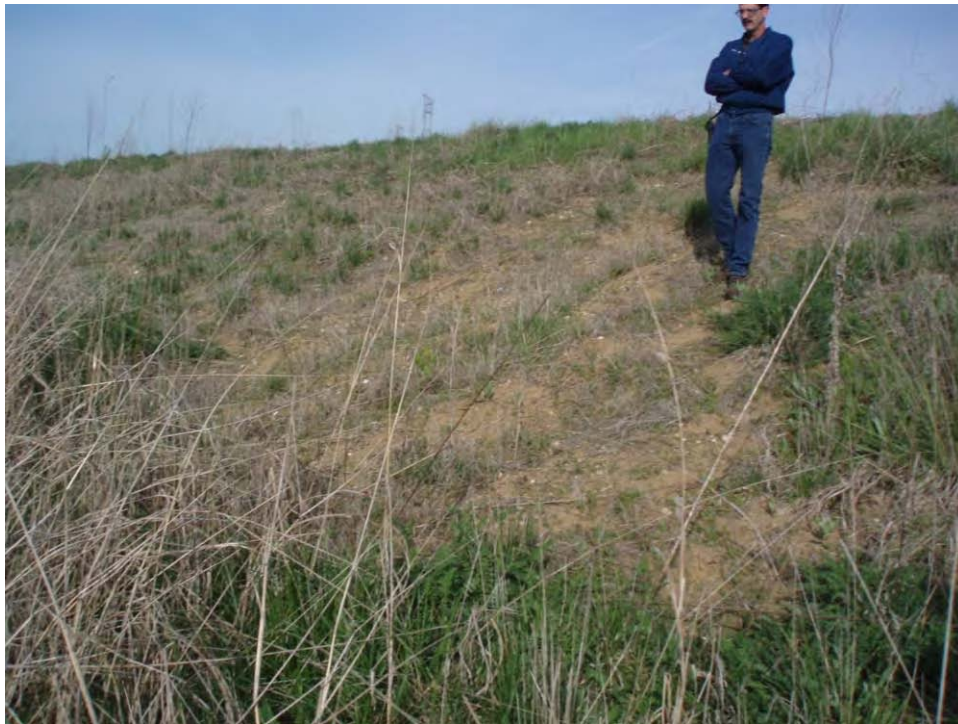
80. Pond D - Large bare spot on upper third of southeast embankment exterior slope, looking northwest.

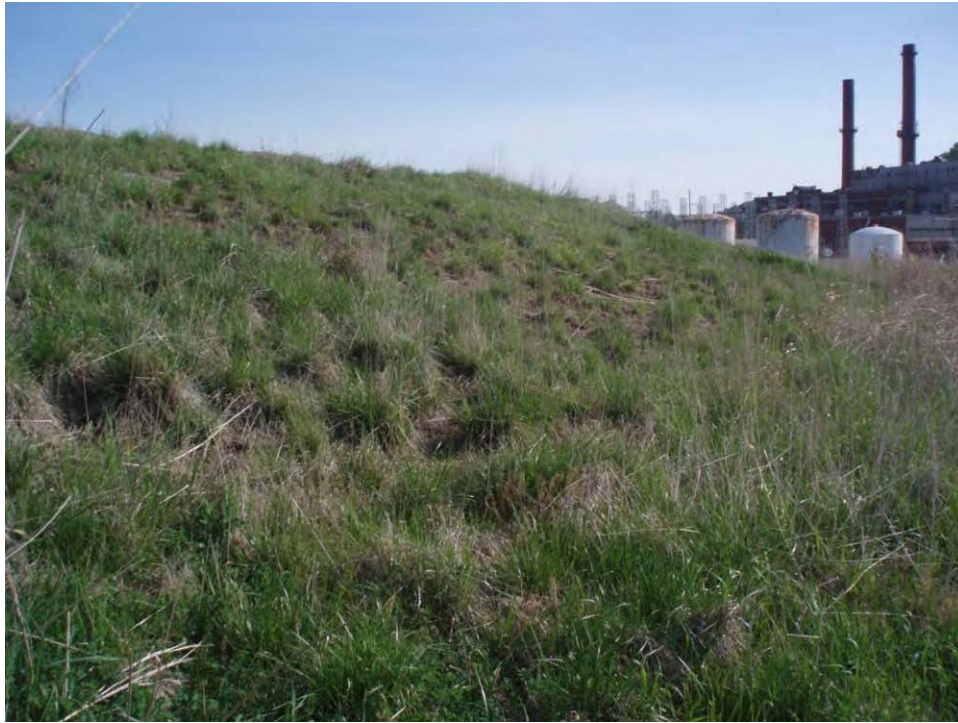
81. Typical bare spots on upper third of Pond D exterior embankment (last expansion).

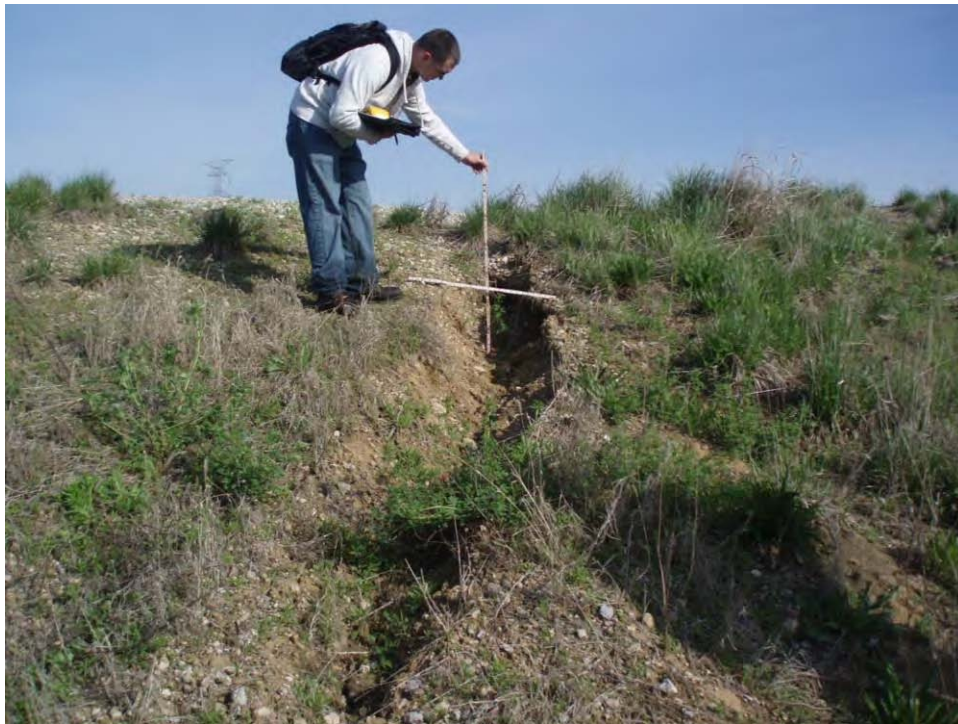
82. Pond D - Erosion rill on southeast embankment exterior slope, looking northwest.

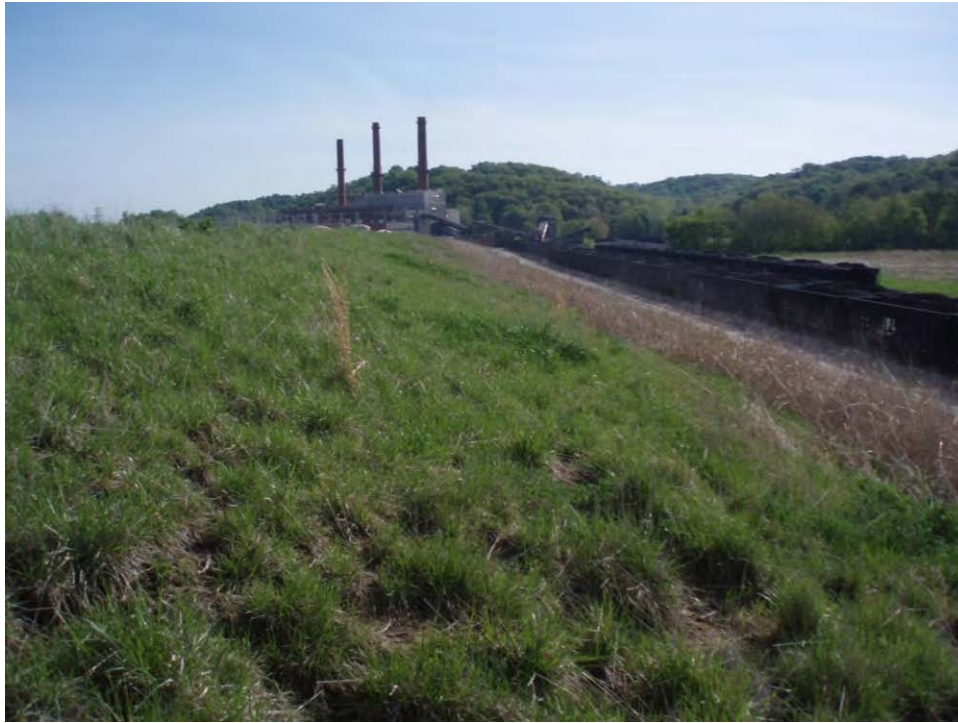
83. Pond D – Southeast embankment exterior slope, looking northeast.

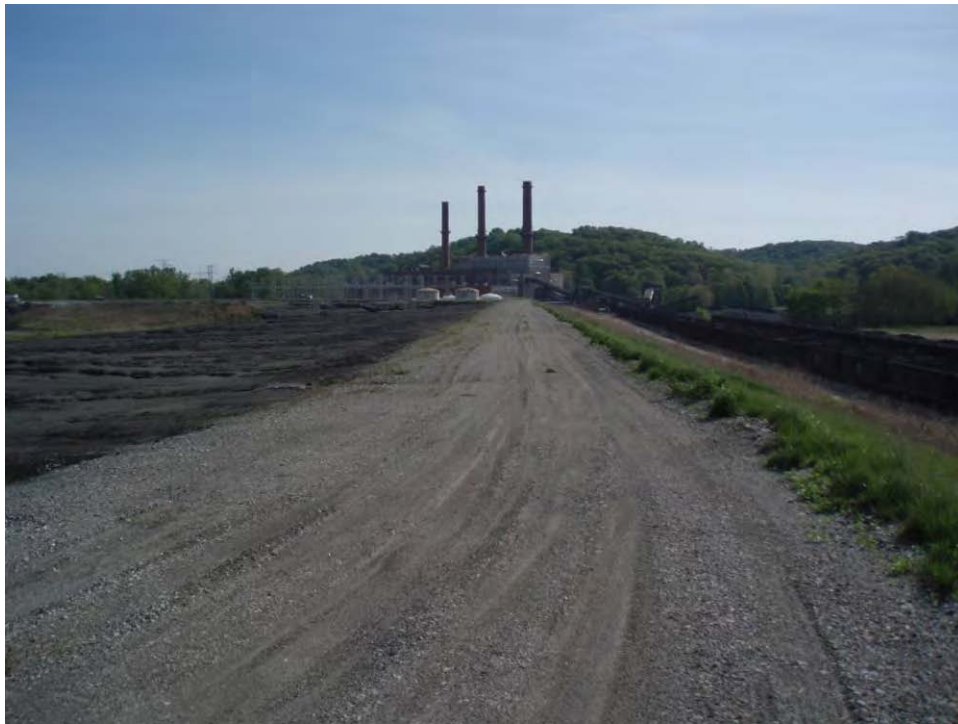
84. Pond D – Southeast embankment crest, looking northeast.

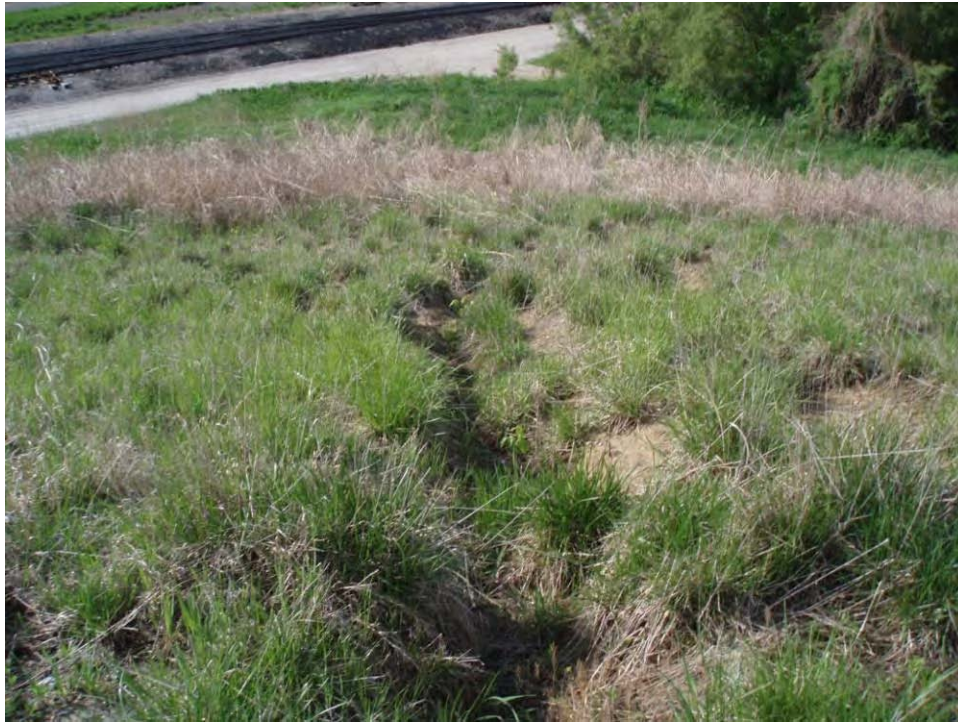
85. Pond D – Erosion rill on southeast embankment exterior slope, looking southeast.

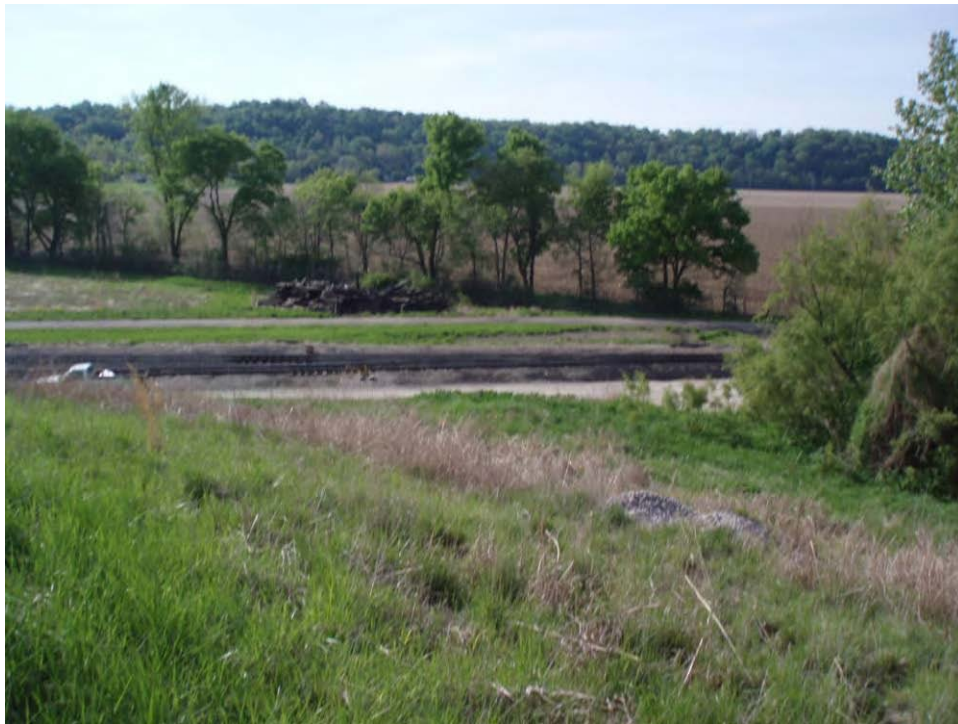
86. Pond D – Southwest corner of southeast embankment exterior slope downstream area, looking southeast.

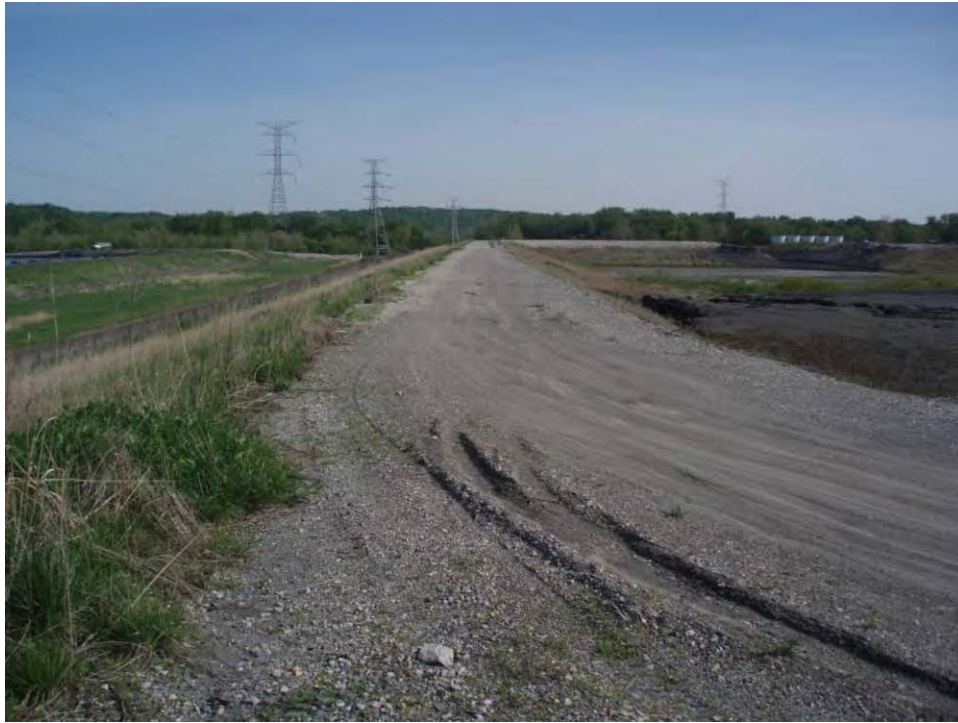
87. Pond D – West embankment crest, looking north

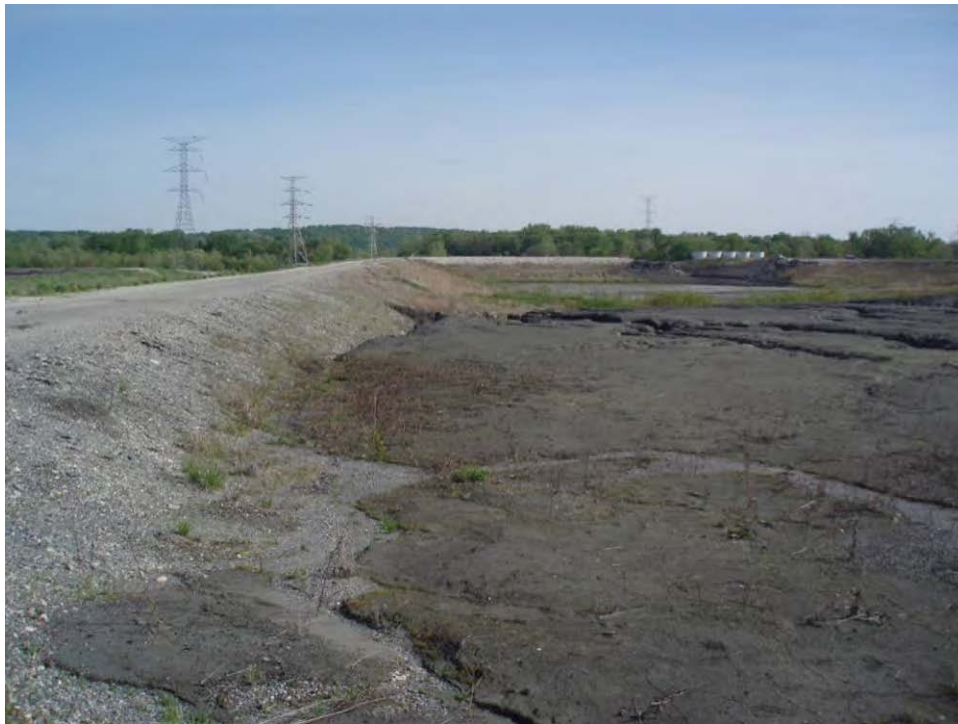
88. Pond D – West embankment interior slope, looking north.
